TECHNICAL REPORT NO. 332

**The Installation of New Temperature Controllers at Narrabri in
2010 February**

Details of the trip to Narrabri in 2010 February are presented.

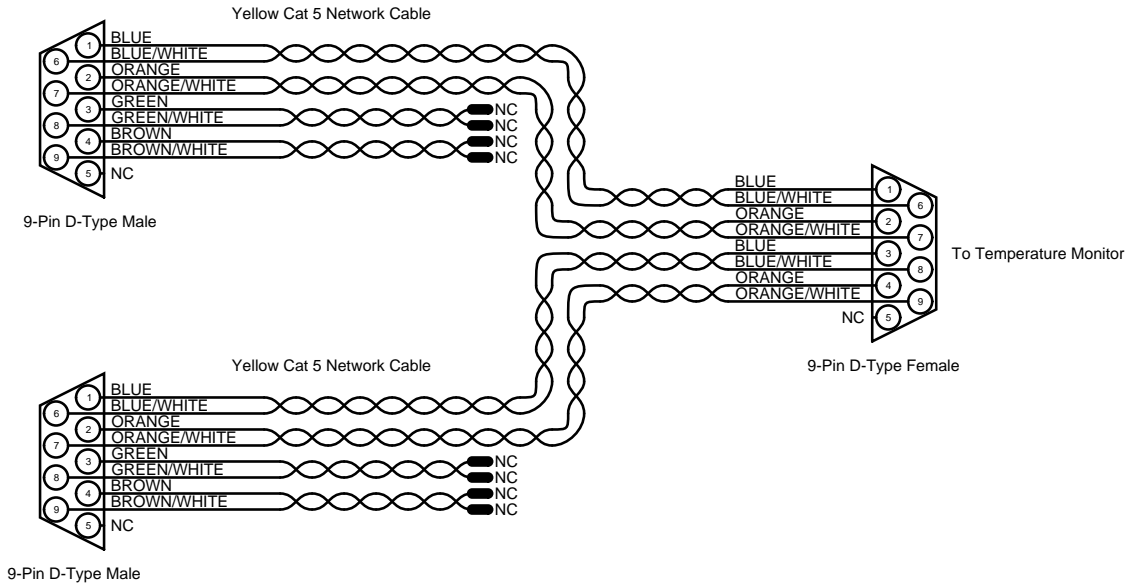
Figure 5: The LM35 wye cable.

In order to combine the room and dome temperatures to use a single connector on the rear of the temperature monitor an LM35-Wye cable was used. The LM35-Wye cable is shown in Figure 5.

The temperature monitor hardware has undergone several hardware revisions since the Narrabri unit was built. Given the lack of the LM35 board and the fact that the cloud detector interface is on veroboard it is strongly recommended that the temperature monitor here gets replaced on the next visit.
